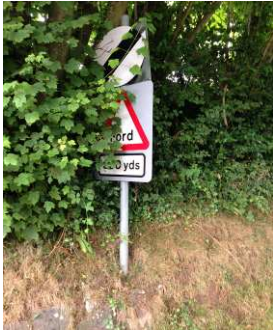
<p>What are the hazards? Who might be harmed and how?</p>	<p>What are you already doing?</p>	<p>What further action is necessary?</p>	<p>Action by whom? Action by when? Date Completed/Outcome</p>
<p>Additional associated ford signing has been erected following a fatality where a car was washed away at a ford in Chew Magna. The Cllr believes the amount of signing is excessive and wants a de-cluttering exercise to reduce the amount of signing due to complaints from local residents.</p> <p>A number of advanced ford warning signing and supplementary distance plates have been erected.</p> <p>The circumstances of the fatality resulted in the car being washed away. The Cllr believes that if it is not feasible for the car to be washed away the signing should not be required.</p>	<p>There are three locations in the Councillors constituent area which have been investigated.</p> <p>The first site is located on a cul-de-sac off The Street, Stowey to a farm. In addition to a No Through Road sign and a derestricted sign an advanced warning sign and supplementary distance plate has been placed at the junction of Stowey Street.</p> <p>The next site is located between Stowey Bottom and Redlands Lane. Two additional warning signs have been erected in close proximity each side of the ford.</p>	<p>The nature of this road/ track does not mean that vehicles will travel down it unnecessarily given that it is a cul-de-sac and the only destination is a farm i.e. there will be no rat-running and therefore it could be considered unnecessary for the advanced warning sign providing the No Through sign remains.</p> <p>The ford is historic and has a raised stone walk way on the western side. The location would benefit from a measuring staff to help determine the depth of the water to help assist approaching vehicles. Although the hedge banks either side will prevent a car being washed away it is not considered appropriate to remove the warning signs at the location of the</p>	<p>Remove the advanced warning sign and supplementary distance plate.</p>

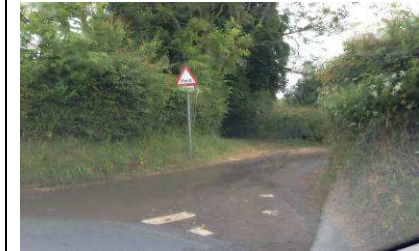
The advanced sign at the Redland Lane junction is located on a road which is not considered a rat run. The forward visibility to this sign is restrictive given it is placed on the inside of a bend and the hedge bank adjacent.

Remove the advanced warning sign at the Redlands Lane junction

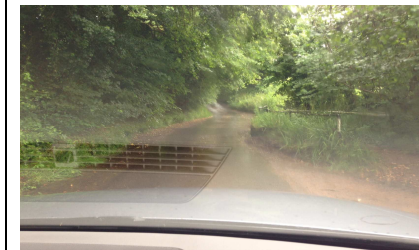
This ford has some long standing ford signing at the ford itself. It is looking worn out and should be replaced reusing some of the signing to be removed if possible. A measuring level staff should also be installed at the ford.

Install measuring staff at the ford.

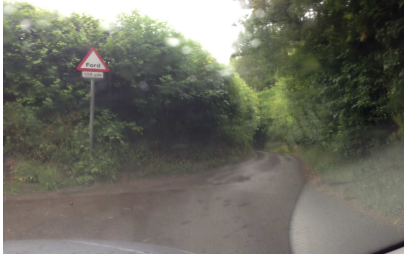
<p>The additional advanced warning sign south of the ford is of limited value when considering the additional advanced warning sign at the junction to the A368 and is surplus to requirements</p>	<p>Remove the advanced ford warning sign south of the ford.</p>
