ROAD SAFETY AUDIT REVIEW

STAGE 1 2

BATH CYCLE NETWORK/POWLETT ROAD SHARED USE

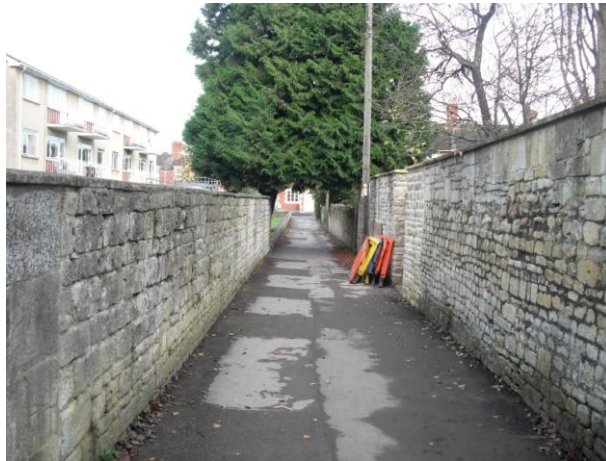
Location: Short central section of the footway between Powlett Road and Bathwick Street.

Summary: Risk of injury to cyclists from overhanging tree branches.

A number of trees along the central section of the footway extend from adjoining properties over the footway. The height of some of the branches is less than the recommended minimum height clearance for cyclists of 2.3m.

Cut back low growing branches to give a minimum 2.3m clearance over the footway.

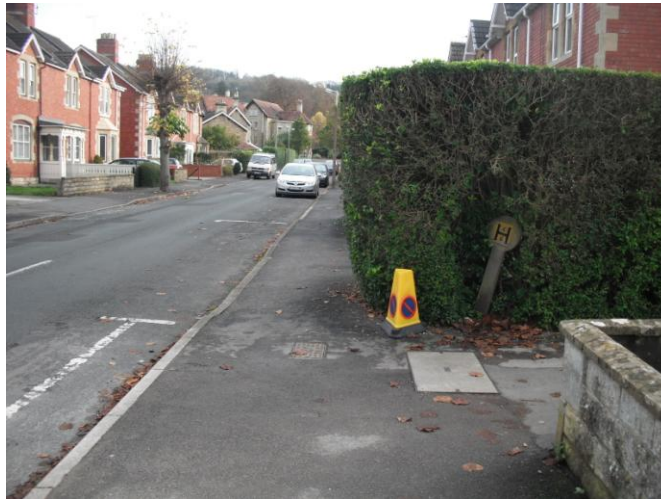
Location: Footway junction with Powlett Road.

Summary: Risk of pedalcycle/pedestrian collisions.

The visibility to the right when exiting the footway at Powlett Road is very limited. This is caused by a hedge in the corner of the garden of an adjoining residential property. Although drawing TC8511/50 shows a proposed Give Way priority and bollard at the junction this will not be sufficient to stop conflicts between cyclists and pedestrians.

Cut back the hedge to the highway boundary to improve the visibility for cyclists exiting the footway, and for pedestrians using the Powlett Road footway of these cyclists.
