# Road Safety Audit Stage 2

Proposed Zebra Crossing  
Bathwick Hill, Bath  
September 2015

Bath and North East Somerset  
Incorporating the Designer's Response

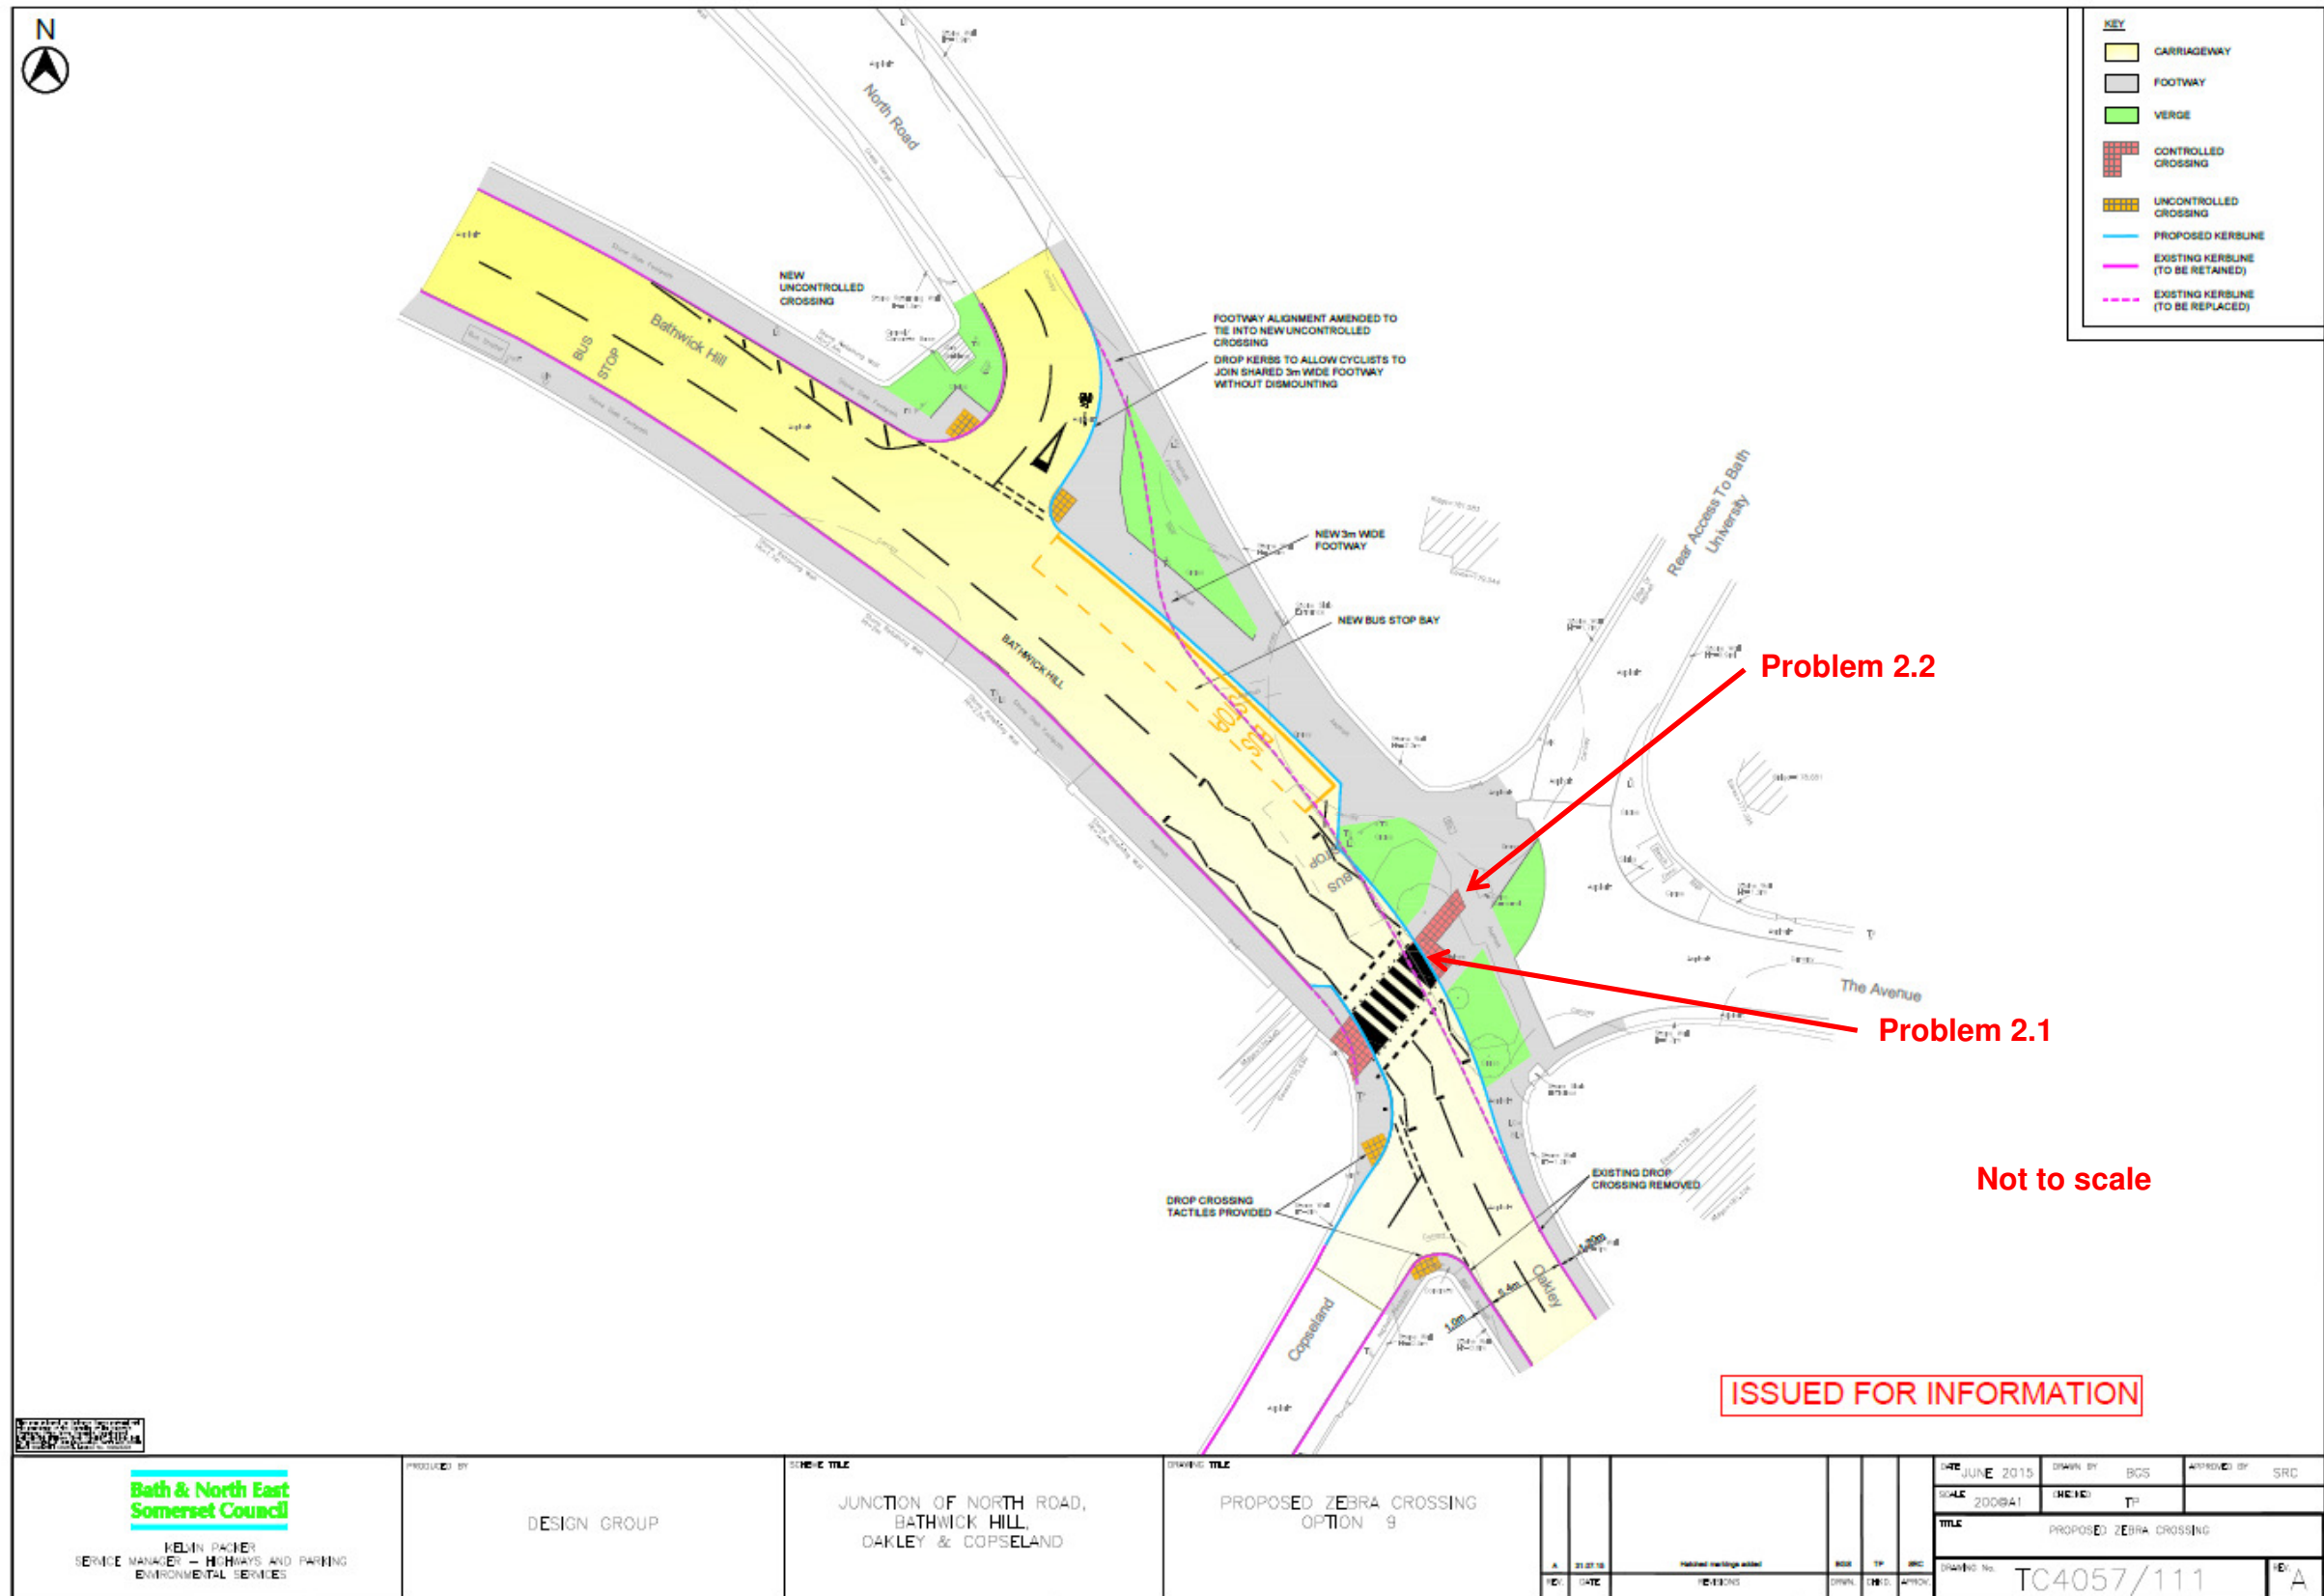
# Appendix B. Location Key Plan

*Location: Zebra crossing west of Copseland.*

*Summary: Cyclist conflict with pedestrians using zebra crossing.*

Dropped kerbs are proposed on North Road for cyclists to join a shared footway/cycleway that extends beyond the crossing on the north-eastern side of Bathwick Hill. However, no dropped kerbs are proposed for cyclists to re-enter the carriageway on Bathwick Hill/Oakley. The existing dropped kerbs on Bathwick Hill to the east of Copseland are to be removed which means the only dropped kerbs for cyclists to return to the carriageway are at the zebra crossing. It is unlikely that cyclists will dismount as they will continue on the north-eastern carriageway as no shared use facility is proposed on the south-western side of the crossing. This could result in collisions between pedestrians and cyclists.

*Location:* North-eastern side of Zebra crossing.

*Summary:* Visually impaired pedestrians may miss crossing.

On the north-eastern side of the zebra crossing red tactile paving in an 'L' shape has been shown, however, it is not shown to extend to the back of the footway. Visually impaired pedestrians from North Road or Oakley/The Avenue may not detect the crossing and instead may cross at an inappropriate less safe location, which could result in collisions between pedestrians and vehicles.

It is recommended that consistent facilities are provided for cyclists to enable them to leave and re-join the carriageway. Cycle facilities should be clearly signed and marked with way-finding signs also provided. If it is anticipated that cyclists are to use the zebra crossing, then it should be a minimum 3.0m in width.

Agree – The zebra crossing will be increased to a 3 metre width

The tactile paving should extend to the back of the footway.

Agree – The tactile will be extended to the back of the footway
