## **Road Safety Audit**

**Stage:** 2

**Location:** Newbridge Hill, Bath

**Proposal:** Zebra crossing

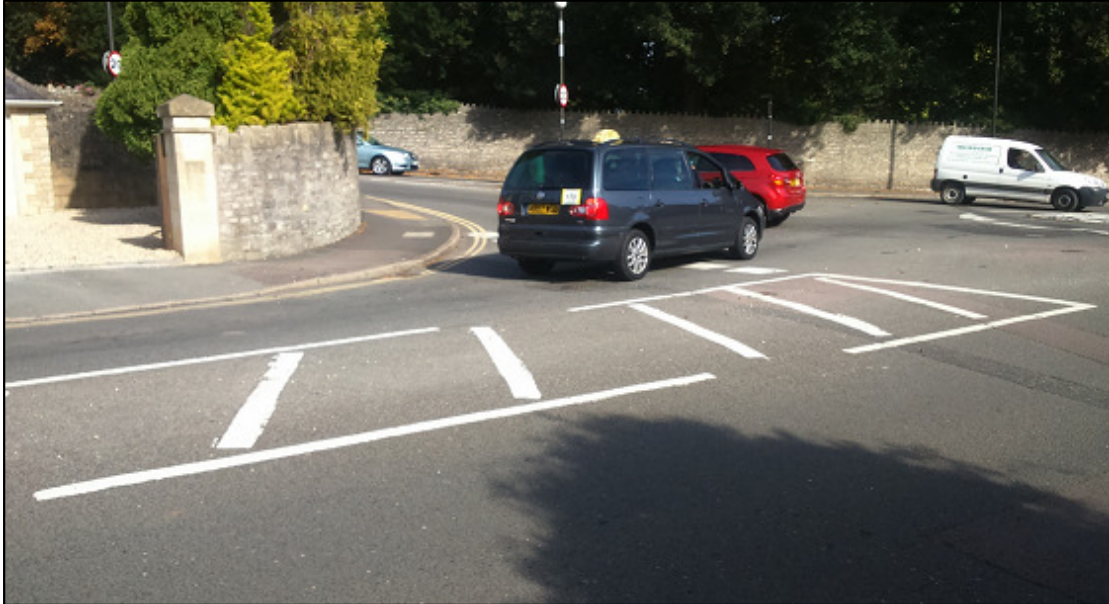
**Location-** Newbridge Hill, eastbound approach to the roundabout junction

Existing one lane exit onto roundabout on Newbridge Hill

**Summary-** Eastbound, two lanes are proposed on the approach to the roundabout. The right turn/straight ahead lane proposal presents an angle of deflection that will create a pinch point for vehicles turning left, particularly if either vehicle is larger than light goods. This will result in side swipe collisions and increases the possibility of nose to tail collisions due to sudden braking.

**Recommendation** – Existing layout to remain the same but with the inclusion of zig zags on the outside of the hatching.

**Agree. Existing layout and hatching to be retained.**

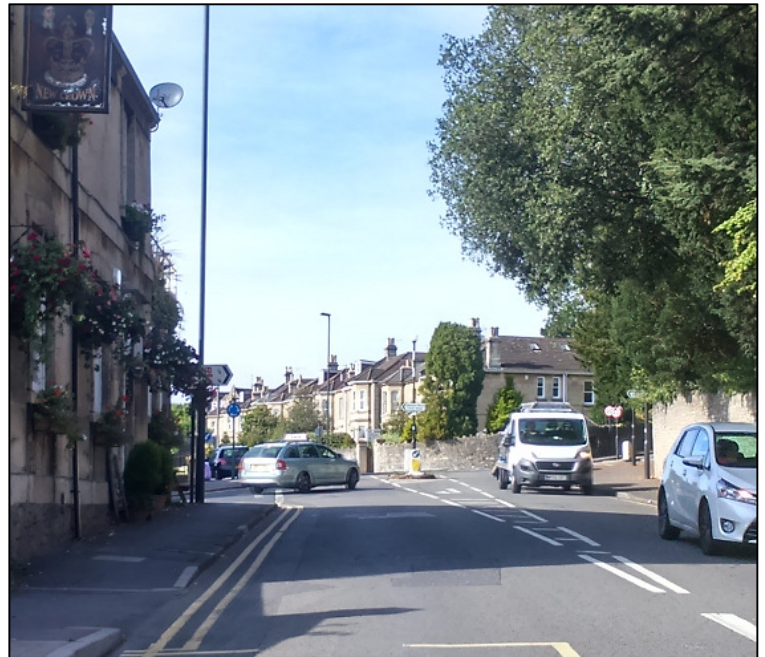
**Location** –Newbridge Hill, westbound approach to the roundabout.

**Summary** – Blue Badge Holders and loading vehicles that park on the double yellow lines outside of the church obscure the visibility of the zebra on the westbound approach, particularly the southern crossing point. Due to the high vehicle speeds in this location, this may lead to nose to tail collisions caused by vehicles stopping suddenly due to the lack of visibility of the zebra crossing and pose collision risk with slow moving pedestrians, i.e- elderly/disabled/children, using this facility.

Westbound approach to proposed zebra & roundabout

**Recommendation** – Because of the distance and road features between the westbound approach to the roundabout and the zebra, it is considered that warning signage is not appropriate in this location. However, as the northern belisha is visible and in the line of sight from the westbound approach, it is recommended that an LED halo and illuminated belisha post is used to promote driver awareness and visibility of the impending zebra.

**Agree. LED halo to be installed if a suitable hood can be fitted. Hood required due to close proximity of housing.**
