RIVER AVON - Pulteney Weir to Bathampton

Danielle Sellwood, BERA (Bathwick Estate Residents Association)

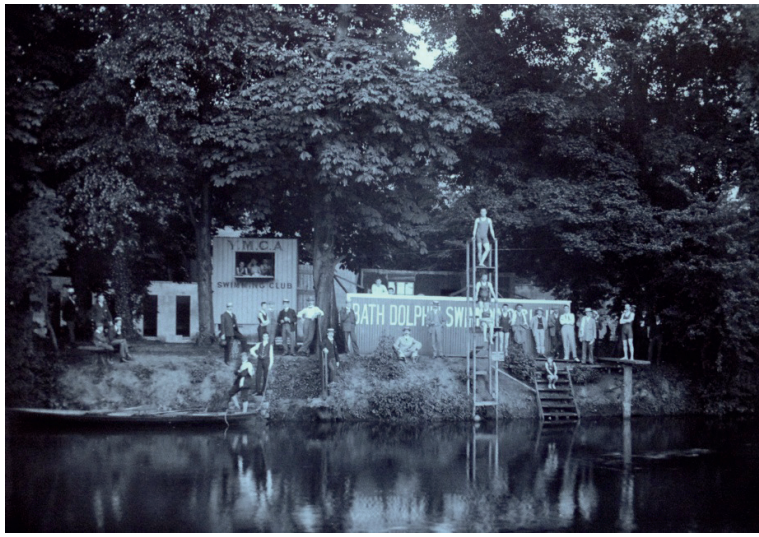
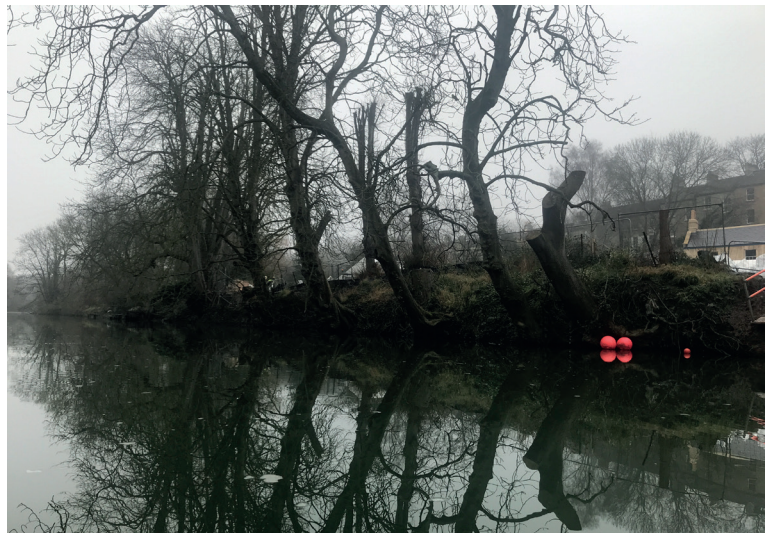
Then and now. On the left is Cleveland Pools in 1910, and on the right, 2022. The loss of several feet of bank is clearly demonstrated by the trees that are behind the scene on the left, but now in 2022 dangerously undercut and hanging off the bank in the picture on the right.

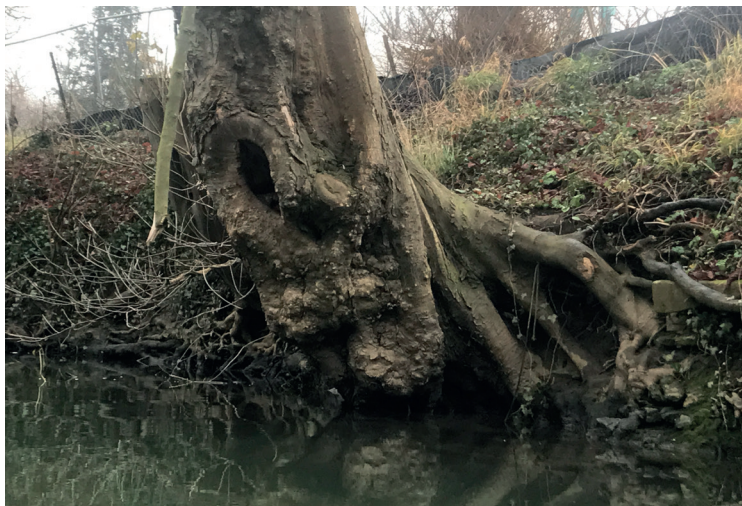
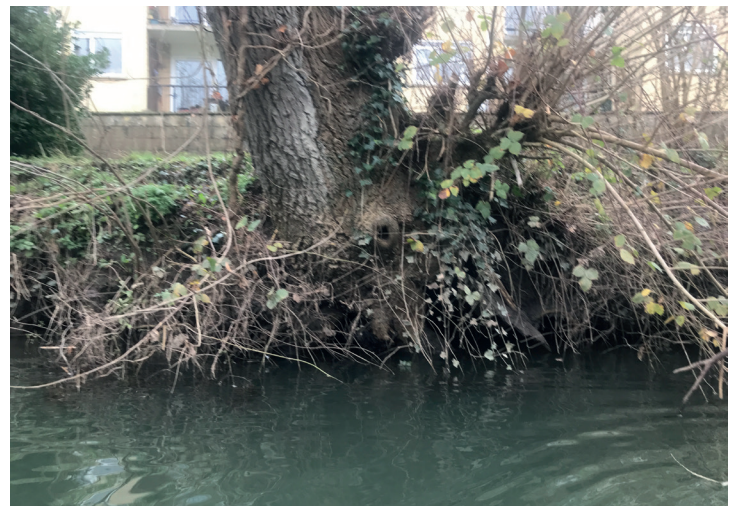
At-risk trees. On the left at Cleveland Pools and on the right at Forester Court, it is clear to see the significant erosion and undercutting of trees at summer river levels (ie. low non-flood level)

- This section of the river must be seen as an important asset for the city and a management plan be put in place.
- Commercial boats to be managed, limited and monitored.
- There must be significant sections of the year when no commercial boats may operate (unless in an emergency) in order to allow the banks and habitat to recover.
- Polluters must be stopped as a matter of urgency.

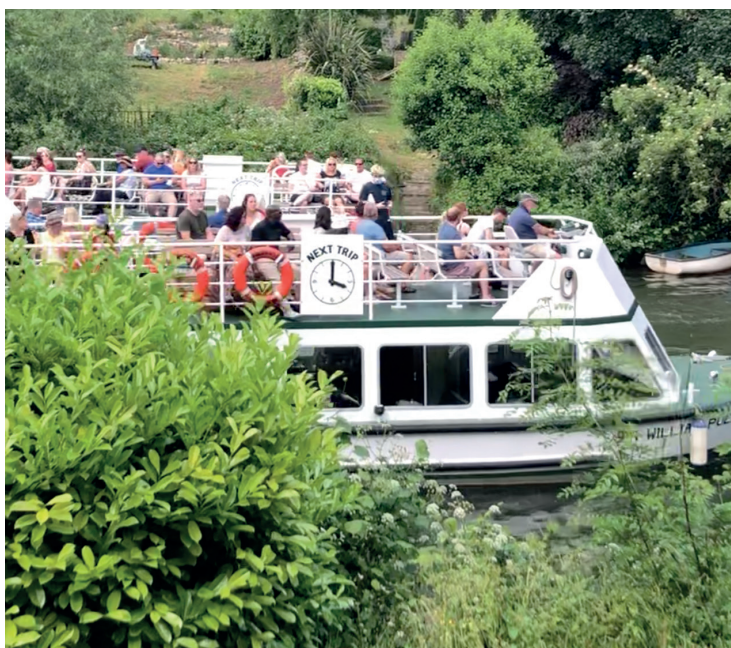
Left. Two tour boats passing close to the banks leaving little room for other users and putting increased pressure on the banks. **Right:** Increasing numnbers of leisure users.
