Expression of Interest : Stanton Drew Play Area

Stanton Drew Play Area C.A.T. Application - *STAGE 2*

This document is an expression of interest from Stanton Drew Parish Council regarding a Community Asset Transfer of the Stanton Drew Parish Play Area from Bath and North East Somerset Council to Stanton Drew Parish Council.

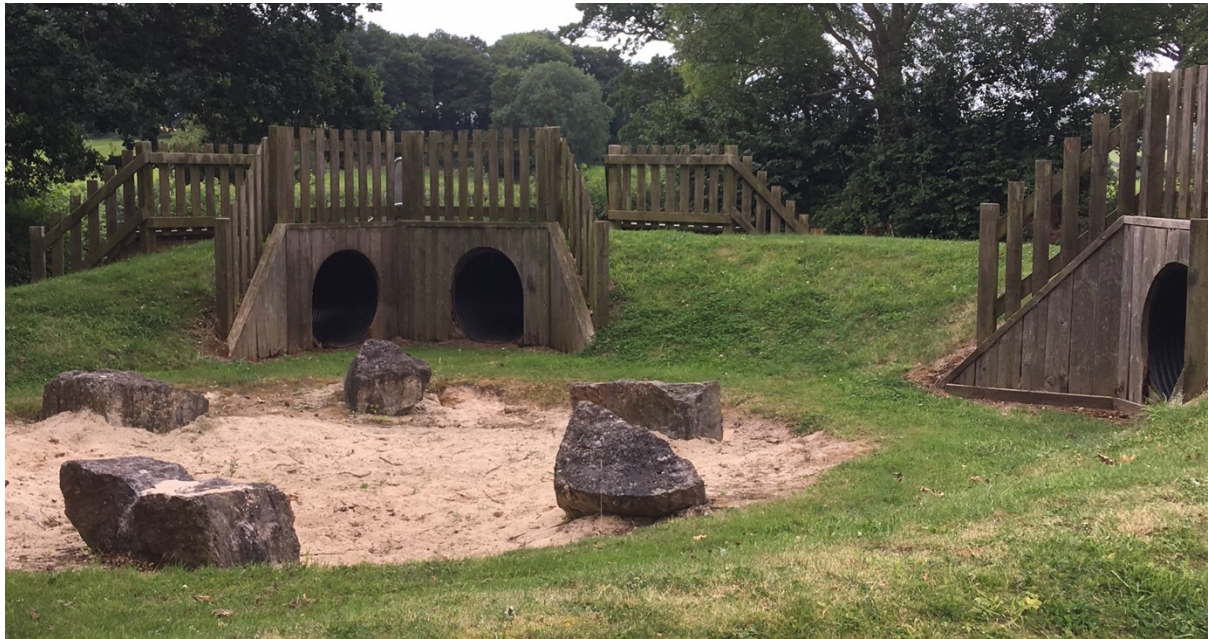
Tunnels with slide at the back, photo from 2019....

ASSET	MANUFACTURER	SAFER SURFACING	RISK ASSESSMENT	Med
Tunnels (Double and Single)	Janes Ponds Landscaping			
FINDINGS				
<ul style="list-style-type: none">◆ The bank around the tunnels is eroding leaving exposed concrete◆ .Numerous timbers are very badly decayed and insecure especially at ground level meaning the rails around the bank are unstable◆ New timbers fitted at ground level are creating trip points at exit /entry of tunnels and could mean tunnel will not drain easily .Some new timbers do not have chamfered or smooth edges at tops.				
IMAGES (if appropriate)

ASSET	MANUFACTURER	SAFER SURFACING	RISK ASSESSMENT	Med
Embankment Slide	Unknown	None visible		
FINDINGS				
<ul style="list-style-type: none">◆ Heavy soil erosion under slide with rocks and concrete exposed to side of slide .◆ Timbers to the top of slide start section are decaying and very slippery .It is noted additional timbers have been added◆ Bank eroding and slippery				
IMAGES (if appropriate)

RECOMMENDATIONS : Replace all decayed timbers and reinstate banks .

RECOMMENDATIONS : Reinststate soil to bank there is evidence (footprints) that children are using the side of slide to pull themselves up the slippery bank . Replace timber steps . Fit countersunk screws to secure slide chute start

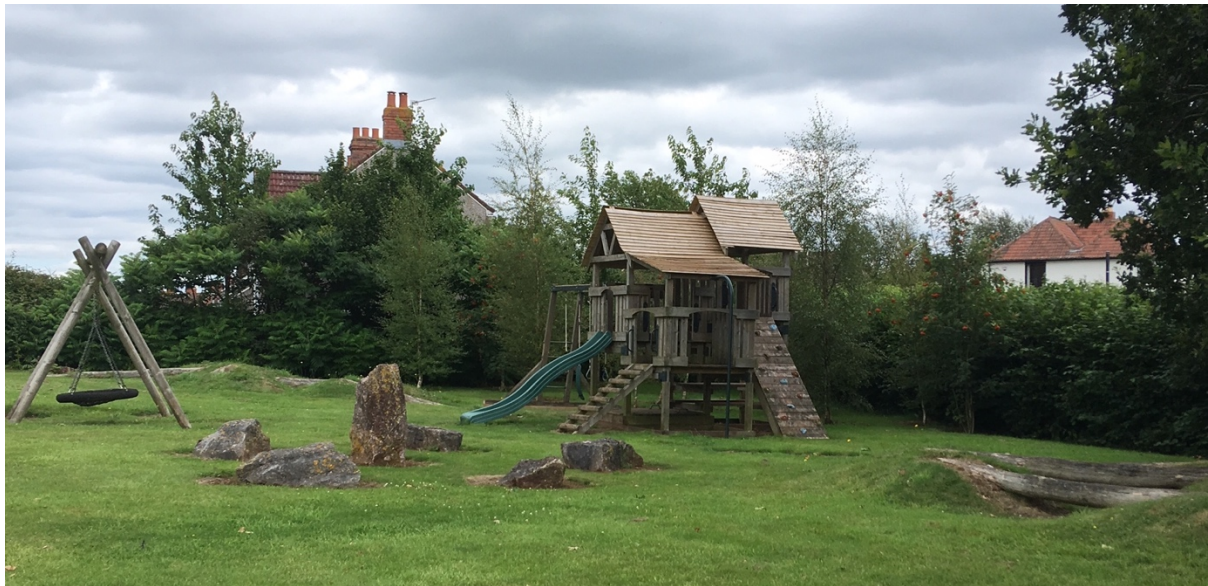
Slide Climber with Swing to the left and Beams to the right, photos from 2019

ASSET	MANUFACTURER	SAFER SURFACING	RISK ASSESSMENT
Slide Climber	Playquest (possibly)	No surface visible	Low
FINDINGS			
<ul style="list-style-type: none">◆ Numerous timbers are decaying.◆ The slide chute is split at the start section and is holding water at runout◆ Components missing from frame .◆ No suitable safer surface is evident around unit .◆ It is evident that some new timbers have been but inspector is unsure if the timbers under neath have been repaired or just covered over◆ There is a roof slat missing from unit			
IMAGES

ASSET	MANUFACTURER	SAFER SURFACING	RISK ASSESSMENT	Med
Basket Group swing	Playquest	Grass matting		
FINDINGS : I no upright post is very badly decayed Unit should be removed from service as a matter of urgency				
<ul style="list-style-type: none"> Seat is a little low Incorrect fitting of swing chains and shackles could increase wear to components. Seat is not sitting level due to the incorrect chains/fittings used this could cause a small user to fall from seat Rope to seat has been damaged and repaired. .Wear to swing joints at crossbar and shackles to chains The free space of item whilst not measured appears to be inadequate between the runout of slide on the climber and the basket swing Timbers have moss and algae growing on them and timbers are splitting The frame appears to be flexing when under load and it appears to inspector incorrect bolts have been fitted to crossbar . 				
IMAGES:

ASSET	MANUFACTURER	SAFER SURFACING	RISK ASSESSMENT	Low
Timber Balance Beams x4	Unknown			
FINDINGS <ul style="list-style-type: none"> Timbers are badly decayed at ends leaving sharp splintering timber 				
IMAGES (if appropriate)

RECOMMENDATIONS :			
Replace all decayed timbers . Repair or replace slide chute. Install a suitable safer surface .

RECOMMENDATIONS : Remove seat and chain from unit as a matter of urgency to prevent further use and possible collapse .				
Refer to annual inspection report regarding the free space between the slide and swing . Note this unit was designed to conform to EN1176-1998 standards we are now on EN 1176 -2017 standards ,

RECOMMENDATIONS : Replace all decayed timbers or remove items from area

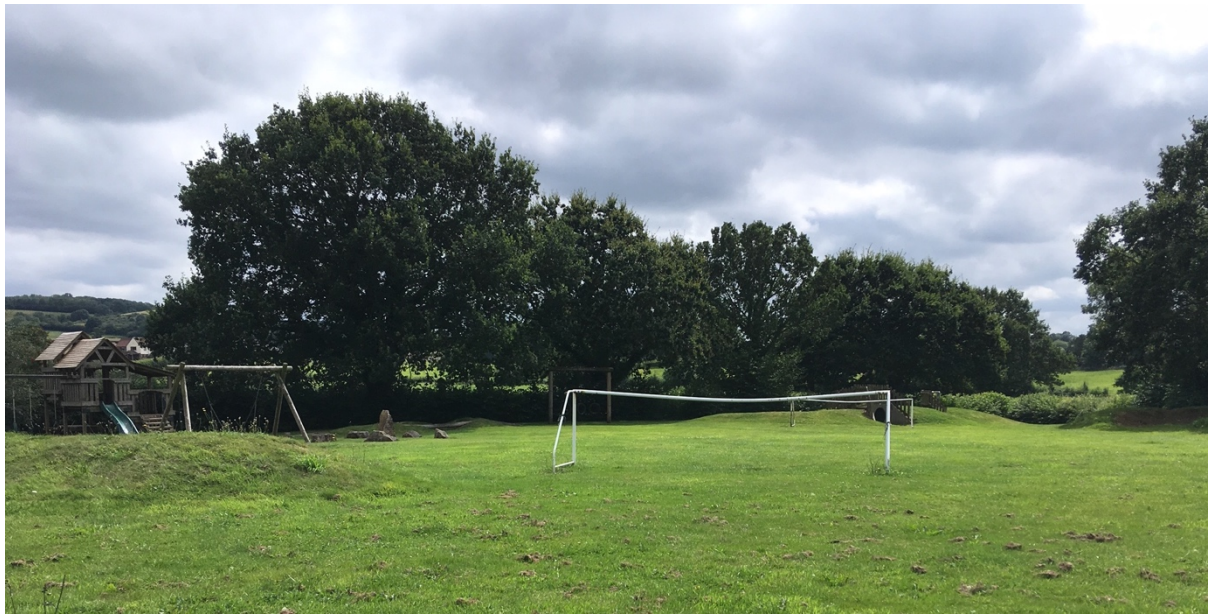
Goal Posts, photo from September 2019

ASSET	MANUFACTURER	SAFER SURFACING	RISK ASSESSMENT	Med
2 no Football goals	Harrods			
FINDINGS				
<ul style="list-style-type: none">◆ Crossbars are badly bent . There is heavy corrosion evident at crossbar joints to both goals this has been painted over but the corrosion is still evident . And goal has corroded to leave a hole at ground level◆ Silicone has been applied around corroded areas				
IMAGES (if appropriate)

RECOMMENDATIONS : As previously reported due to overall condition of goals it is recommended the goals are replaced or removed from site.
